Failure rate determination and Failure Mode, Effect and Criticality Analysis (FMECA) based on historical data for photovoltaic plants

Sara Gallardo-Saavedra^{1,2}, Javier Pérez-Moreno², Luis Hernández-Callejo¹ and Óscar Duque-Pérez³

Abstract

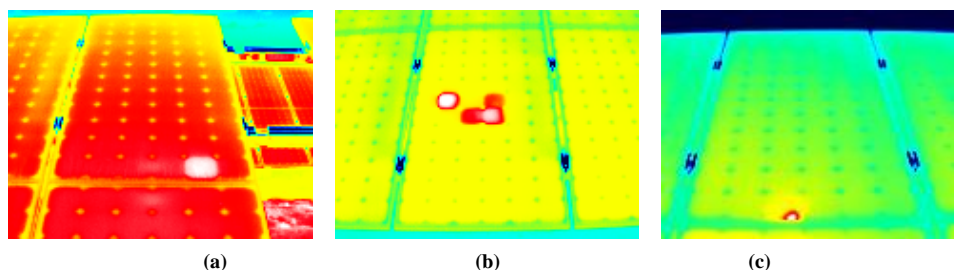
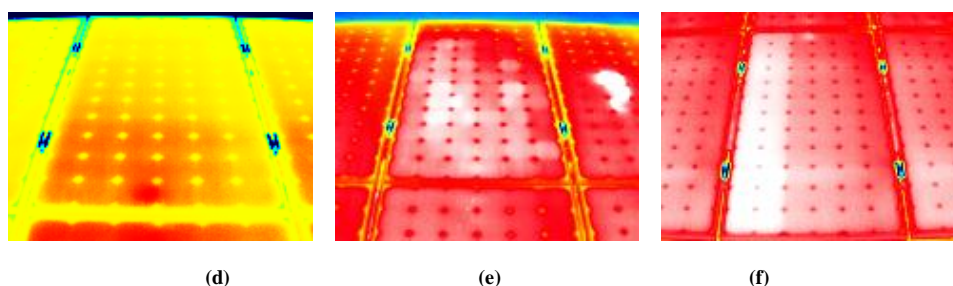
Thermographic tests have been applied at a module level to a sample of the base data to complete the FMECA of the whole PV Plant. Some of the module failures that generate a difference in the temperature are experimentally identified by thermographic techniques and their criticality is analyze, as the overheating in multiple or one cell, connection point, module box, whole module and one row or bypass circuit. The thermographic images obtained performing on-site manual thermographic inspection are presented in Fig. 3.

Fig. 3: Thermographic image of PV modules taken on-site with a manual thermographic camera which presents different defects (a) hot spot, (b) multiple cells hot spot, (c) connection overheated (d) module box overheated, (e) whole module overheated, (f) bypass circuit overheated.
