# ANALYSIS OF FAILURE AND DEGRADATION MODES OF SMALL-SCALE PHOTOVOLTAIC POWER PLANTS IN RURAL COMMUNITIES OF THE ATACAMA DESERT

## Abstract

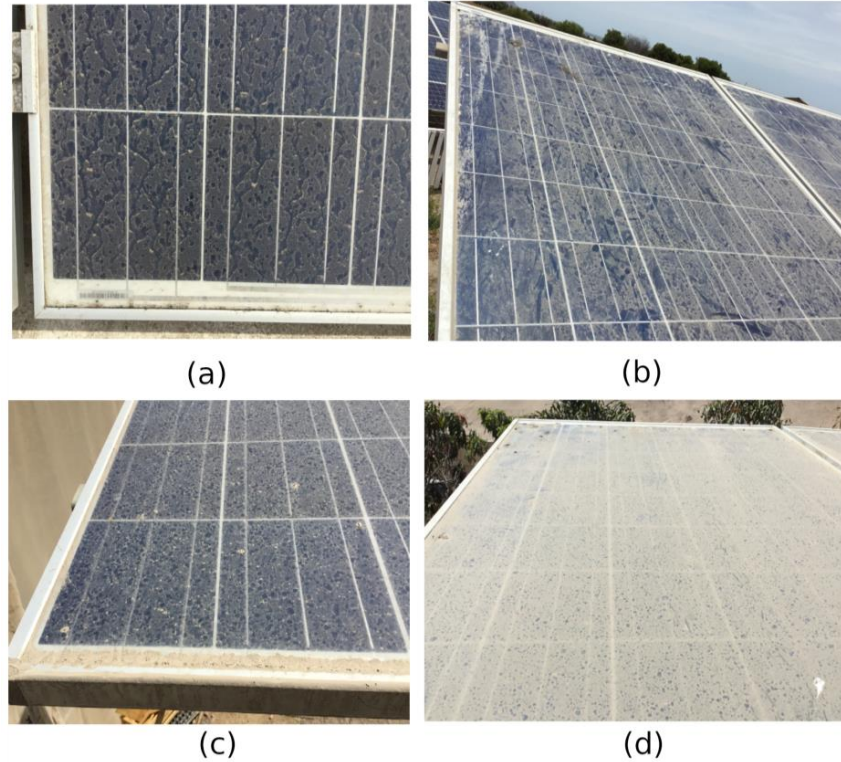
For the case of heavily soiled modules, a detailed inspection of visual images shows that, apart from general information about the relationship of soiling with electrical parameters reduction, soiling deposition patterns can be distinguished according to the location of affected modules. As shown in Figure 3, for the four zones considered (see Figure 1), it was found that modules located near the seashore and outside the city (zone A and D) show a groove deposition pattern (type I), possibly related to humidity and wind (a). Inside the city, modules located near the seashore show inhomogeneous distribution of soiling layers (type II), attributable to the presence of pollutants from vehicles, industry or other activities inside the city (b). On the inner valley (c)

and (d), modules show a uniform distribution of soiling layers across the surface. Also, there was found a set of 6 modules with a particularly dense dust layer deposited on them, phenomena that was also reflected in the I-V measurements. For this reason, ‘moderately’ heavy soiled modules and ‘extremely’ heavy soiled modules are classified as type III and type IV respectively, considering that the difference between these two types is only the thickness of the soiling layer.

Figure 3: Different deposition patterns shown by heavily soiled modules according to their location: (a) coast, (b) coastal zone inside city and (c), (d) inner valley.

Being the most extended issue found in the analysed sample, soiling is also the easiest to revert, by simply cleaning the modules. In desert areas, a well-planned cleaning protocol can be a key to avoid further problems with PV modules. However, specialized training for small/domestic owners who may not be familiar to PV plants operation may assure a correct exploitation of them.

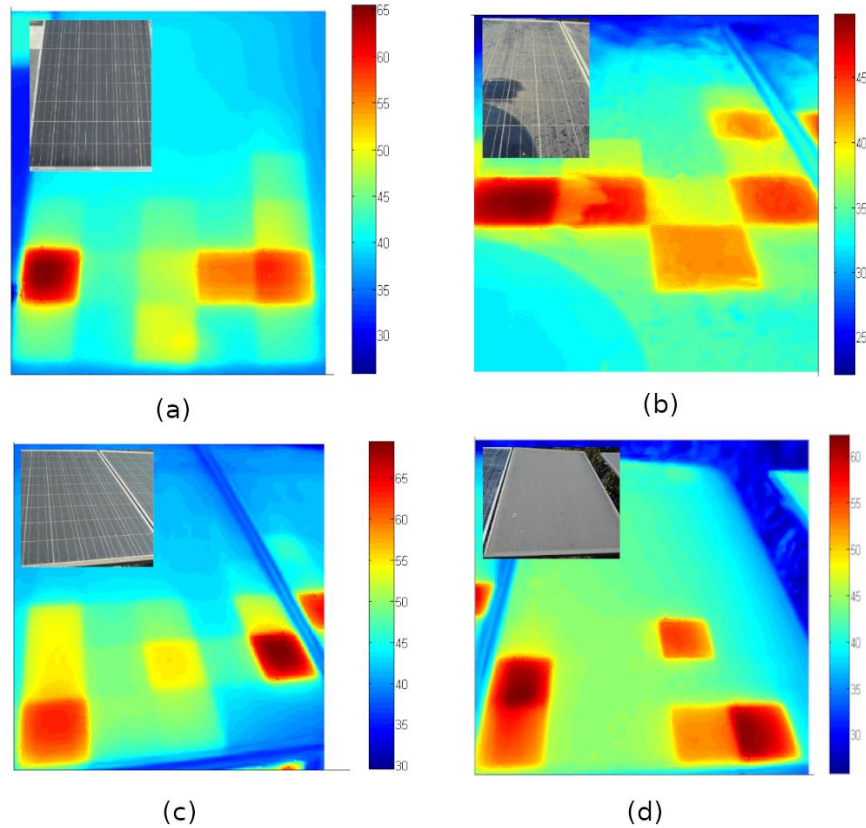
According to the classification of soiling by means of modules location, it was found that, in general, modules tend to show even temperature profiles (despite individual variations) with hotter cells at the bottom or centre of modules. Thermal images of modules according to their soiling type are shown in Figure 4 and the average operating temperature of modules belonging to each soiling type are shown in Table 3. As shown, average operating temperatures range from 37.9 to 47.9°C, despite individual cell temperature variations which will be detailed in next subsections.

Zone	Soiling pattern	Average temperature [°C]	Electrical parameters deviation [%]		
			$V_{oc}$	$I_{sc}$	$P_{mpp}$
Coast	I	37.9	-3.7	-15.1	-18.5
Coastal city	II	38.4	-4.7	-10.1	-14.2
Inner valley	III	47.9	-3.5	-36.5	-19.1
	IV	42.5	-4.7	-55.3	-63.2

**Figure 4: Thermal patterns of heavily soiled modules according to their soiling type: (a) coast, (b) coastal zone inside city and (c), (d) inner valley.**

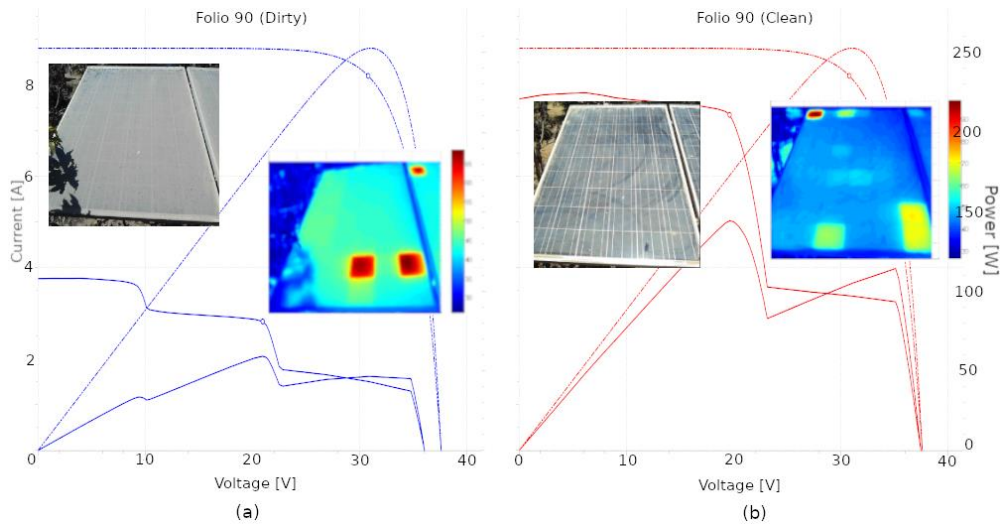
A special case was found in the inner valley with a soiling pattern type IV. Due to the extremely thick layer of soiling affecting those modules (see Figure 4d), their I-V characteristics show a severe decrease of both  $I_{sc}$  and  $V_{oc}$  parameters. In these 6 cases, two electrical measurements were performed: the first one with the module severely soiled and after the module was cleaned. First, it was observed that the short circuit current, which reductions ranged from 53.2 to 61.6% improved to a range between 2.8 to 12.9% with respect to the nominal value, therefore, losses due to this parameter were mainly due to the soiling layers. Voltage reductions were not as severe as in the case of the current, improvements for the open circuit voltage changed from 3.8 - 5.5% to 0.2 - 1.7%. On the other hand, temperature profiles show that module average temperatures were lower for the modules when they were dirty than after cleaned. Given that dirty modules generate a lot less current, then, thermalization losses also decrease, which explain why dirty modules are cooler. Temperature rising was between 2°C and 7°C after cleaning. Additionally, it was observed that in all modules the presence of strong hotspots (cells with temperatures higher than 20°C than the module average temperature) varied significantly from dirty to clean state. As shown in Figure 5, both, the plant shadow and the soiling layer, contribute to the reduction of electrical output, which is partially recovered after the module is cleaned. However, the hot cells shown in the dirty state are not the same than those in the clean state. Also, in the dirty case, the two hotspots are no hotter than 70°C, while in the clean case the hot cell at the corner reaches 99°C. A possible reason for this can be explained with the bypass diodes. In the dirty case the partially shaded string may be bypassed and after the cleaning and removal of the plant, the second string is bypassed (the cell in the 3<sup>rd</sup> string remains around 70°C). So it is probable that severe shunts remain covered by other external anomalies that cause activation of bypass. A similar behavior (electrical and thermal) was observed in the other 5 modules.

Figure 5: I-V/P-V characteristics, visual and thermal images of a module (a) heavily soiled and partially shaded, (b) after cleaning and cleared.

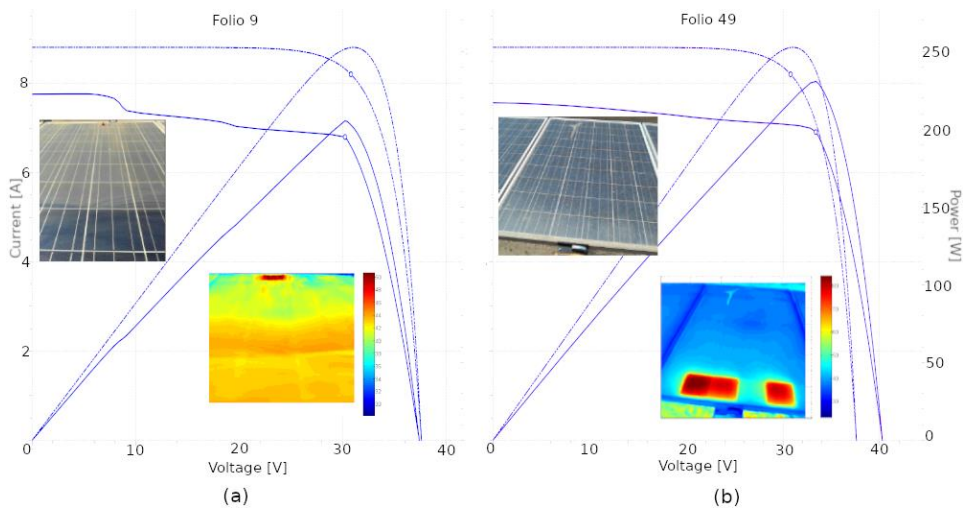
Milky discoloration of the front glass is not a very documented topic, but it seems to obey a change in composition of the glass that prevents the passage of light to the cells. From the total sample, two modules were found to show extensive milky discoloration (ED), accompanied with a weathered surface appearance and a fine layer of soiling, while 6 other modules showed localized discoloration (LD), all at their bottom cells, added to a fine layer of soiling. All these modules are in the inner valley area (zone C) and at the time of inspection were operating for 6 and 7 years. Both these cases show alterations in their electrical parameters, mainly in  $I_{sc}$ . However, in some LD modules the measured voltage surpasses the nominal voltage, suggesting the presence of reverse biased cells, not enough to activate bypass. Also, a pronounced slope near the  $I_{sc}$  is observed, suggesting a decreased shunt resistance. This is reinforced by the thermal images, which show severely heated cells in the areas of LD, as shown in Figure 7, reaching temperatures between 80 and 94°C.

Figure 7: I-V/P-V characteristics, visual and thermal images of modules with milky discoloration of the front cover glass (a) extensive, (b) localized in the bottom cells.

While for a precise diagnosis of the underlying mechanisms that may be causing this issue, data provided from visual inspection, electrical measurements and thermal images suggest that interactions between the front glass and the environment are affecting the glass features. Despite the aridity that characterizes these locations, weathering was also observed, and thermal images show that the cells affected by discoloration are being forced to currents higher than they can deliver, thus, leading to severe heating. For further study, it would be interesting to research elemental interactions (changes in structural composition, optoelectronic features) of environmental particles surrounding modules and the front glass, considering that this last may vary from one manufacturer to another.

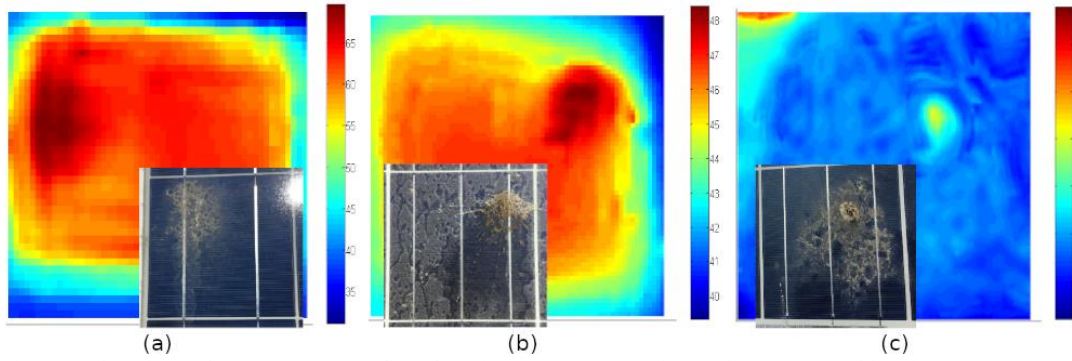
Partially shaded cells were found, in all zones, in three ways: modules shaded by plants/trees, cells with mud or bird drops, and cells with localized dust deposition. As shown in Figure 8, a comparison between visual inspection and thermal profiles show that in the case of a localized dust deposition (a) the hottest area of the cell, although near, is not completely coincident with the shaded area. The temperature difference between the hottest point of the cell and the rest of the module is very high ( $dT = 40.6^{\circ}\text{C}$ ), which can be an indicative of other issues (shunts, for example). For other partially shaded cells, severe heating was neither found. As shown in Figure 8b-c, temperature differences of shaded areas and the rest of the cells are between 3 - 6°C while these differences with respect to the rest of the module do never surpass 7°C. All these modules were found to be operating within zones A and B (coast and city) for which the presence of birds and moisture are more common than those of inner zones.

Figure 8: Visual inspection and thermal profiles of partially shaded cells by (a) localized dust deposition, (b) mud drop and (c) bird drop.

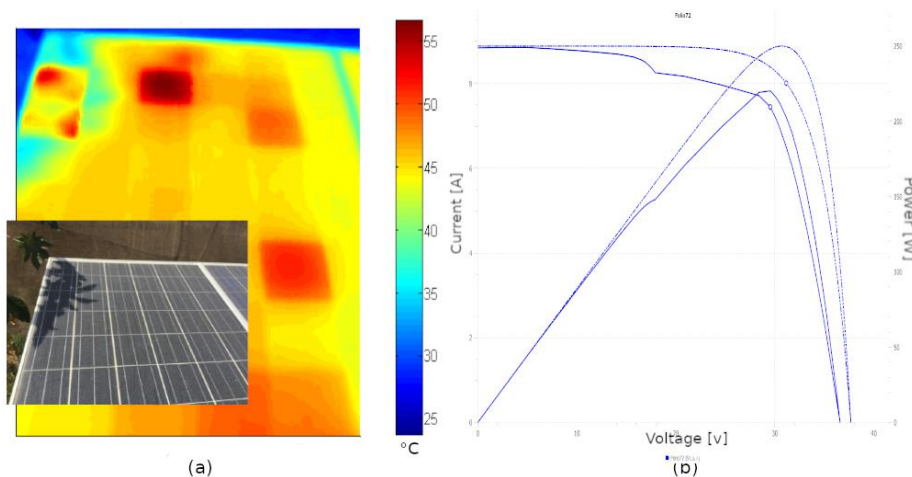
Regarding to modules partially shaded by trees or plants, found in zone C, where the land sharing between PV facilities and other activities (mainly agricultural) is very common, the following was found. As shown in Figure 9, the shaded area comprises the upper left cells of the module, which thermal profile shows a notable change in temperature within the most shaded cells. It can be noted that shaded areas are characterized by cooler temperatures (with respect to the rest of the module), while non-shaded areas within the affected cells show a temperature rising up to 52°C. The I-V/P-V characteristics shows a notable current mismatch between one string and the rest of the module, probably due to the limited generation of the shaded string. However, the module also shows a strong hotspot non-correlated to visible anomalies and a layer of soiling on its surface. Therefore, the electrical behaviour of the module cannot be attributable entirely to the shading effect.

Figure 9: (a) Visual inspection, and thermal profiles and (b) I-V curve of a partially shaded module due to the presence of a tree.

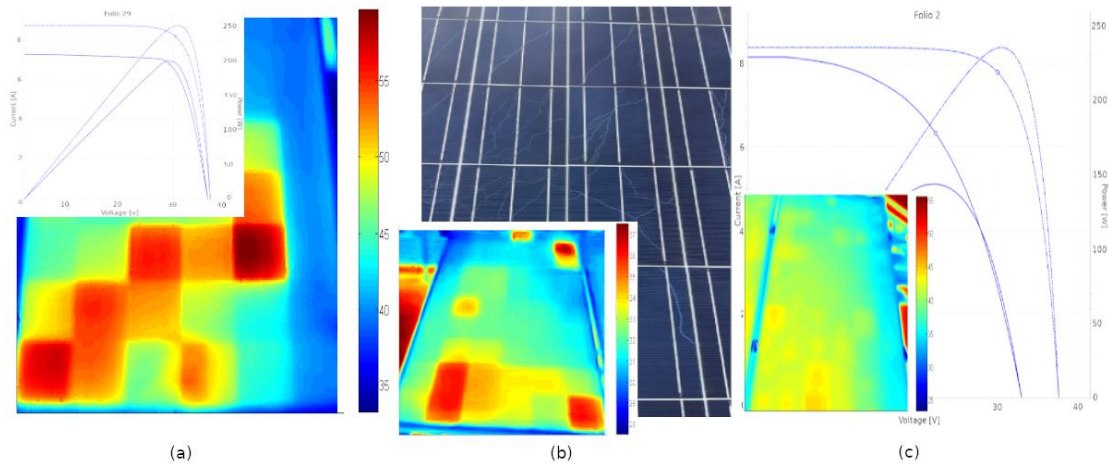
electrical measurements or the visual inspection, so further analysis is required in this case. Faulty soldering can be also detected by an uneven temperature distribution, as shown in Figure 9a, in this case one half of the cell appears hotter than the other half. In this case, the thermal abnormality found corresponds with a slightly increase of the series resistance in the I-V curve.

The last interesting case was a module with a thermal pattern and I-V characteristics of Potential Induced Degradation (PID). In domestic PV facilities, it is common to find defective, or even absent grounding systems, which may favour the appearance of PID issues. In the case of the Atacama Desert, it is more common to find modules suffering from PID in the coastal region. This corrosive salty environment promotes leakage currents between the cell, front glass and aluminium frame. As shown in Figure 9c, this module shows hotter cells mostly at its bottom and mid regions, and upper region near the frame. The temperature differences are roughly 5°C from the PID affected zones in comparison to the rest of the module, with one warmer cell at the bottom (near 45°C). Electrical measurements show degradation of  $V_{oc}$  and rounding of the knee, at the  $P_{mpp}$ .

**Figure 9: Thermal and visual detection of (a) possible faulty soldering, (b) slight delamination and (c) PID.**
