# PERFORMANCE ANALYSIS AND DIAGNOSIS OF A PHOTOVOLTAIC MODULE WITH SPONTANEOUS CRACKING

<sup>1</sup> SENAI Innovation Institute for Renewable Energy, Natal (Brazil)

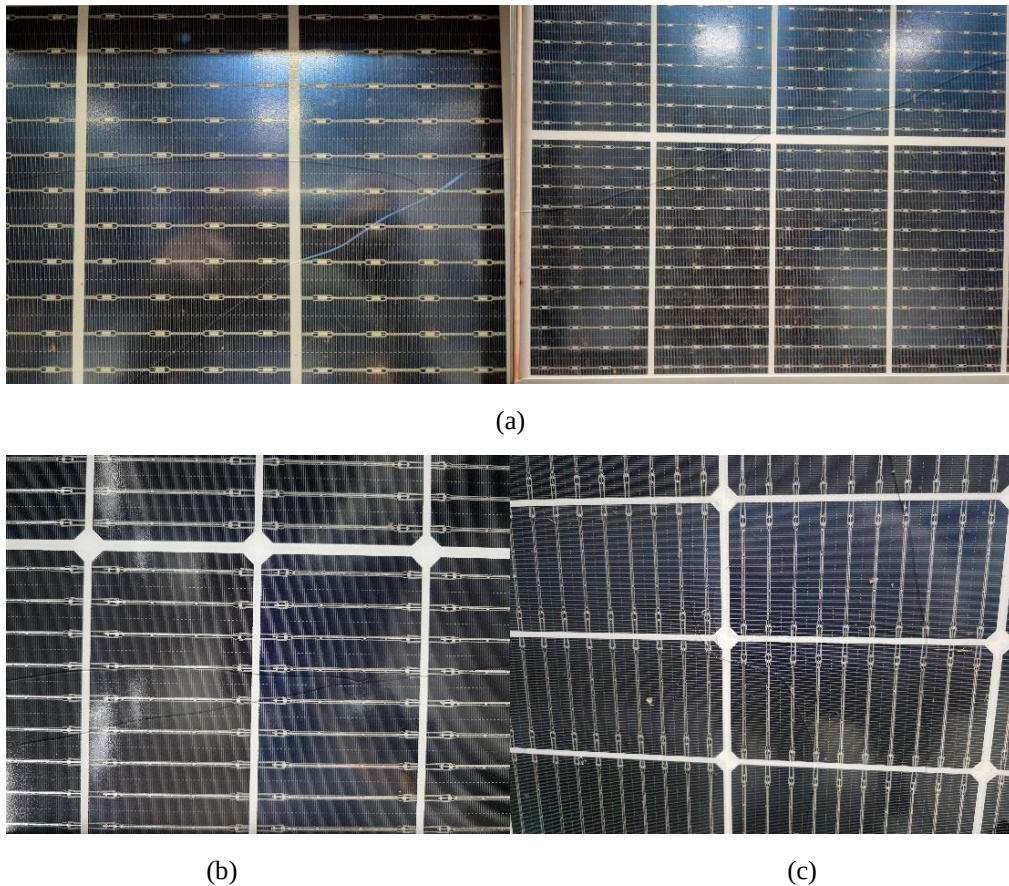
**Fig. 1: Cracks on the rear of the photovoltaic modules (a) 1, (b) 2 and (c) 3.**

The analysis of the results begins with the visual inspection test, during which cracks were identified on the rear surface of the photovoltaic module, as illustrated in Fig. 1. A closer examination revealed that these cracks exhibited continuous propagation across the entire length of the module, extending from one edge to the other. In addition, several secondary branches were observed emerging along the main fracture lines, suggesting a complex pattern of mechanical stress distribution and propagation within the encapsulated structure.

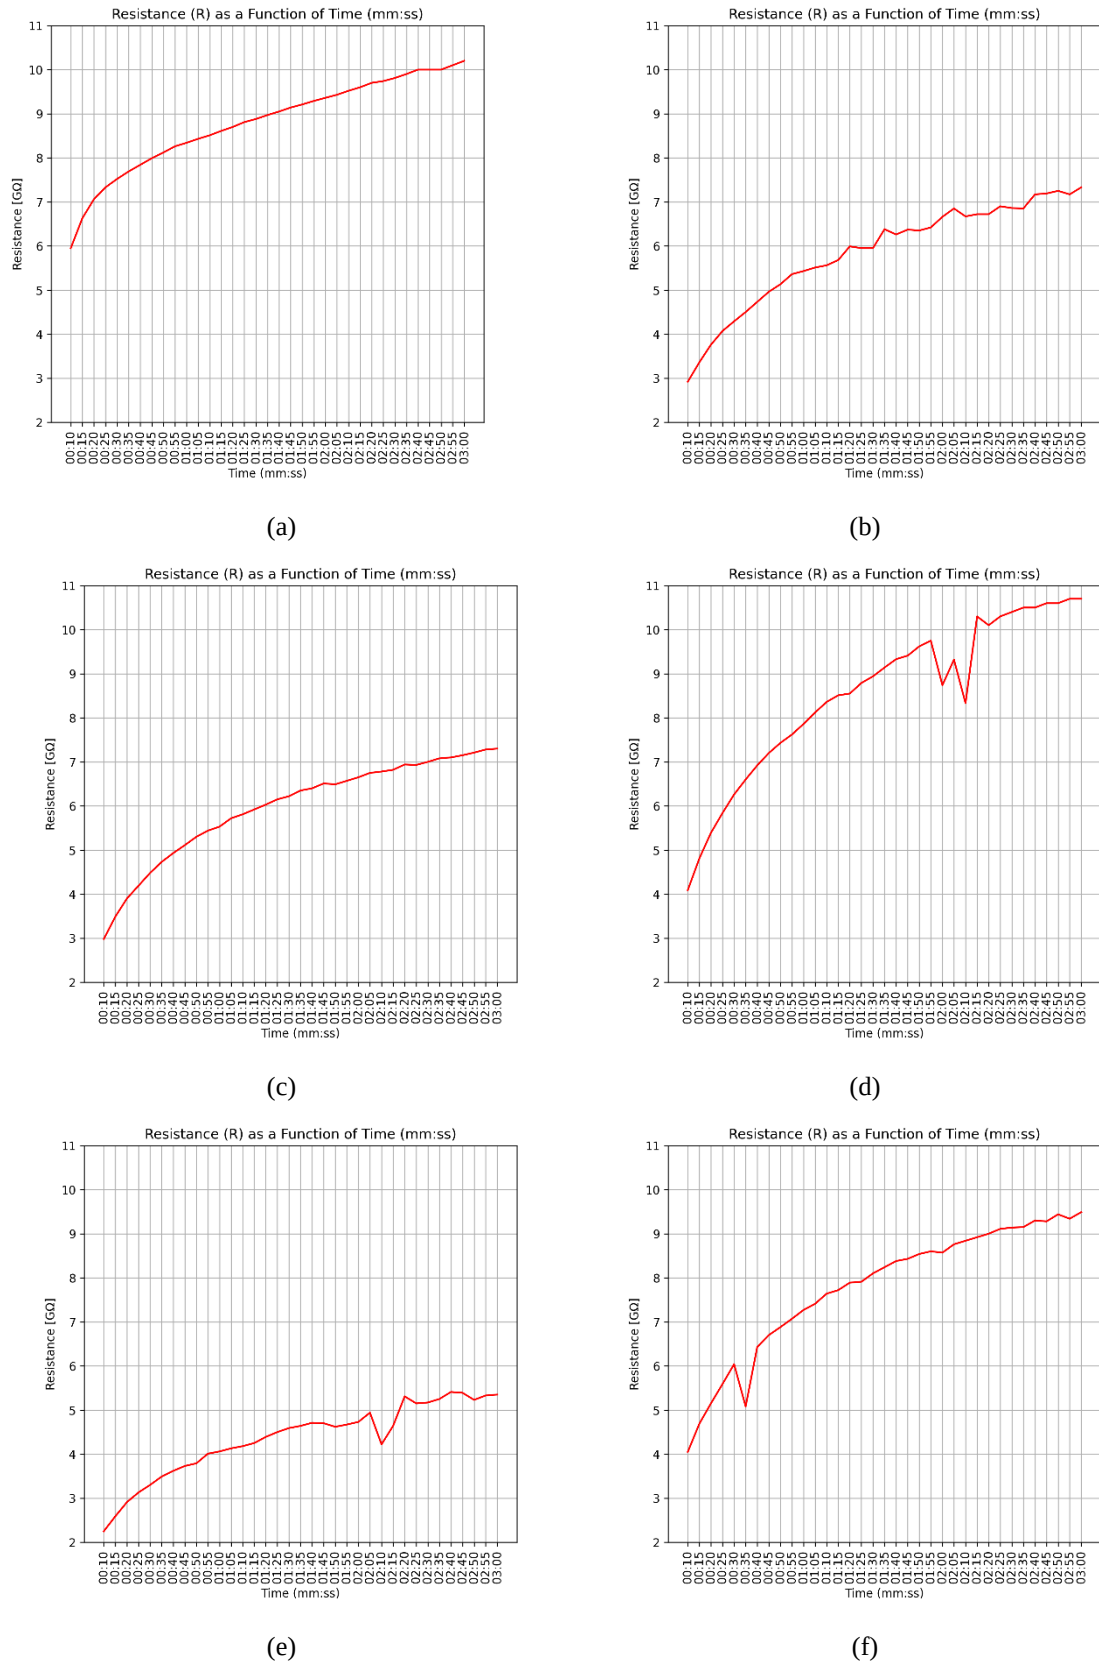
As shown in Fig. 2, all tested photovoltaic modules exhibited insulation resistance values well above the minimum requirement of  $40 \text{ M}\Omega \cdot \text{m}^2$  specified by the standard. These results demonstrate that the presence of spontaneous cracks did not compromise the electrical insulation, indicating that no significant leakage or deterioration occurred during the test.

Fig. 2: Insulation tests from the Modules (a) 1, (b) 2, (c) 3, (d) 4, (e) 5 and (f) 6.

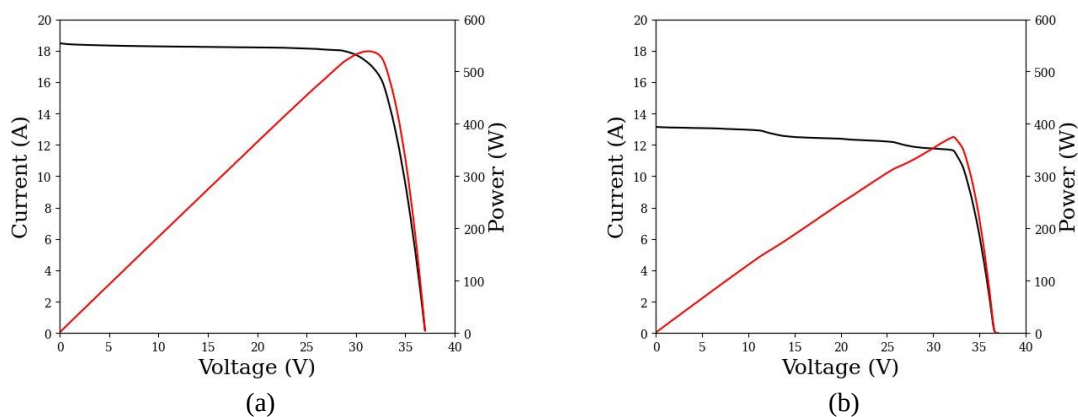
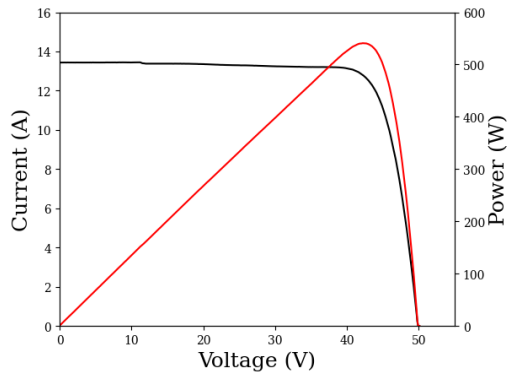
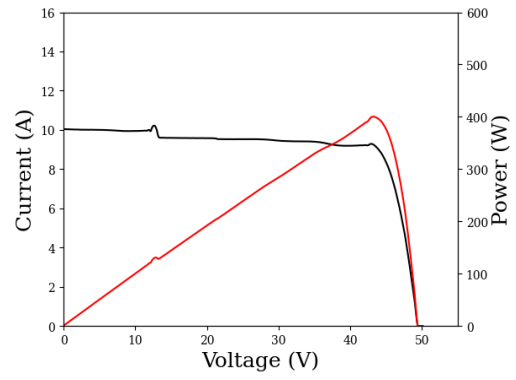
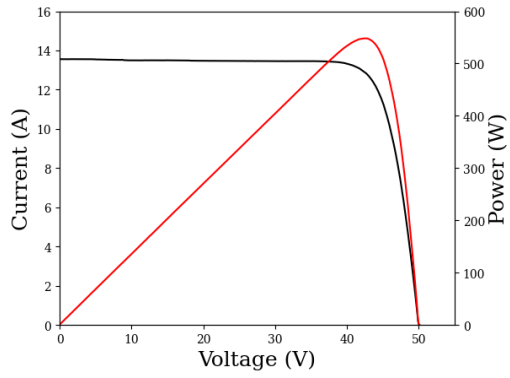
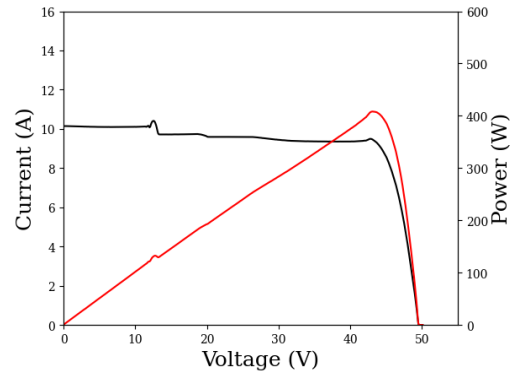
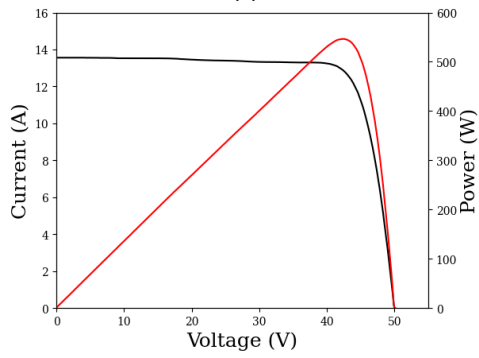
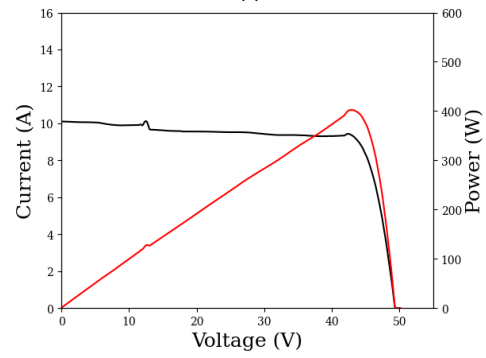
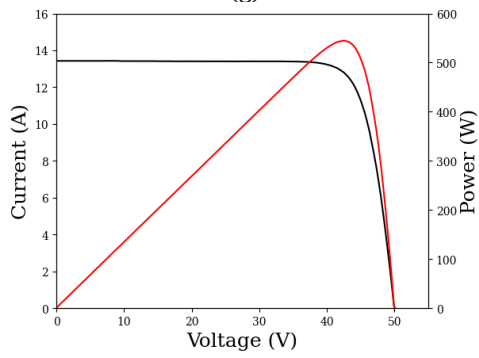
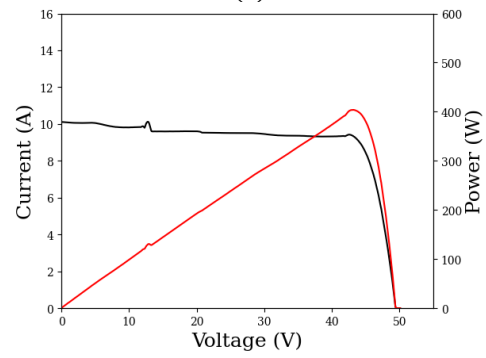
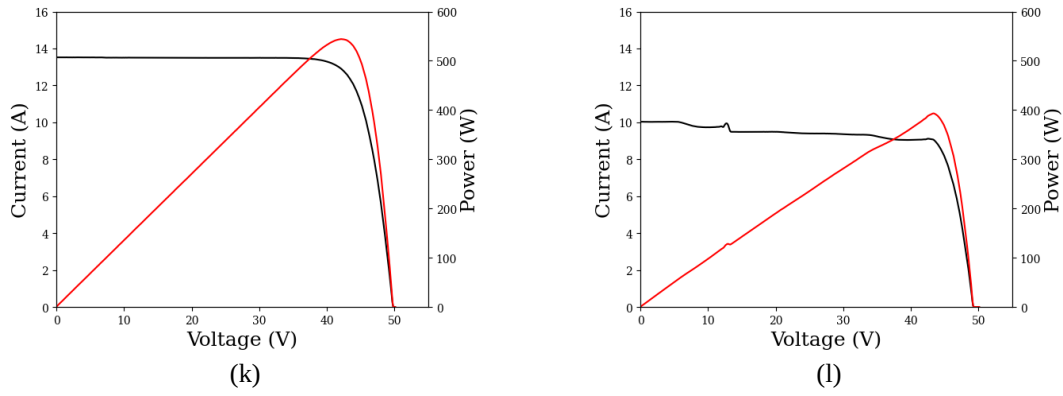
Fig. 3 presents the individual current–voltage (I–V, in black) and power–voltage (P–V, in red) characteristics measured for both the front and rear sides of the photovoltaic module. The results demonstrate a strong agreement with the nominal data, indicating consistent electrical behavior under standard test conditions. As expected, the rear-side measurements exhibit slightly lower values due to partial shading caused by the metallic frame and the junction box, which limit the effective irradiance on the rear surface. Similar to the findings of the insulation resistance test, the module remains fully operational and maintains its expected efficiency, confirming that the presence of surface cracks did not lead to any measurable degradation in its performance.

**Fig. 3:** I-V and P-V curve measurements performed on module 1 (a) front and (b) rear surfaces, module 2 (c) front and (d) rear surfaces, module 3 (e) front and (f) rear surfaces, module 4 (g) front and (h) rear surfaces, module 5 (i) front and (j) rear surfaces and module 6 (k) front and (l) rear surfaces.

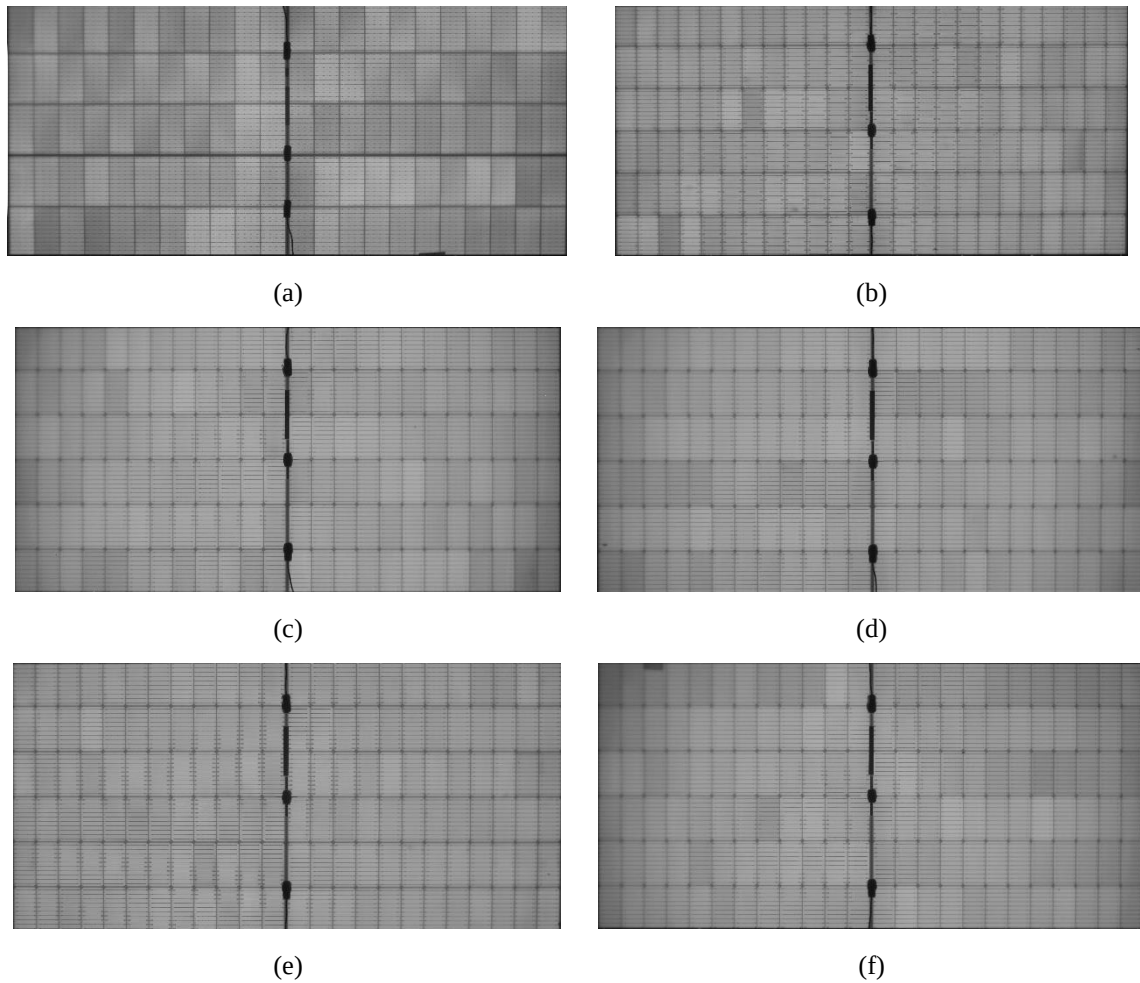
The electroluminescence (EL) imaging test was conducted to evaluate the internal condition of the photovoltaic module and identify possible microcracks or inactive regions within the solar cells. As presented in Fig. 4, no signs of electrical damage were detected in the areas corresponding to the visible cracks on the glass surface. The EL image revealed uniform luminescence without dark regions or disruptions in the emission pattern, indicating that the mechanical cracks were confined to the glass layer and did not propagate into the silicon cells. Consequently, the structural integrity and electrical continuity of the cells remained unaffected by the observed surface defects.

**Fig. 4:** EL of the rear side of the PV modules(a) 1, (b) 2, (c) 3, (d) 4, (e) 5 and (f) 6.

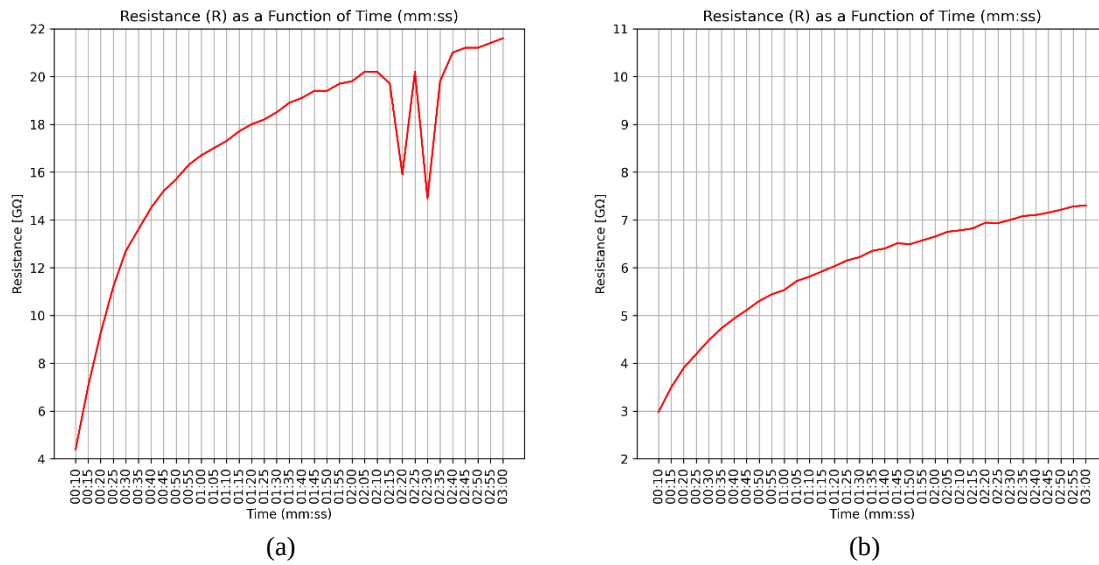
Fig. 5 shows the comparison between the insulation resistance test performed before and after the appearance of cracks. The results demonstrate that, even after the occurrence of the cracks, the insulation resistance remains above the acceptable threshold defined for the module. This indicates that the mechanical damage did not immediately compromise the module's electrical insulation integrity.

Fig. 5: Insulation test of the Module 3 (a) before and (b) after the cracks.

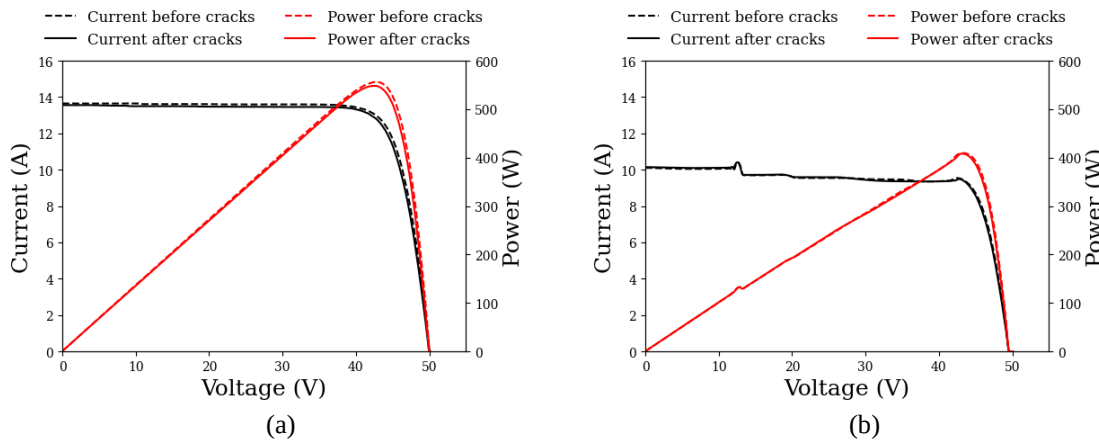
Fig. 6 presents the comparison of the maximum power determination test conducted on the front and rear sides of the modules before and after the appearance of cracks. The results show that the presence of cracks did not cause a significant reduction in power output on either side of the module. This indicates that, at this stage, the cracks in the glass do not immediately affect the electrical performance of the cells.

Fig. 6: Maximum power determination test from Module 3 (a) front and (b) rear sides.

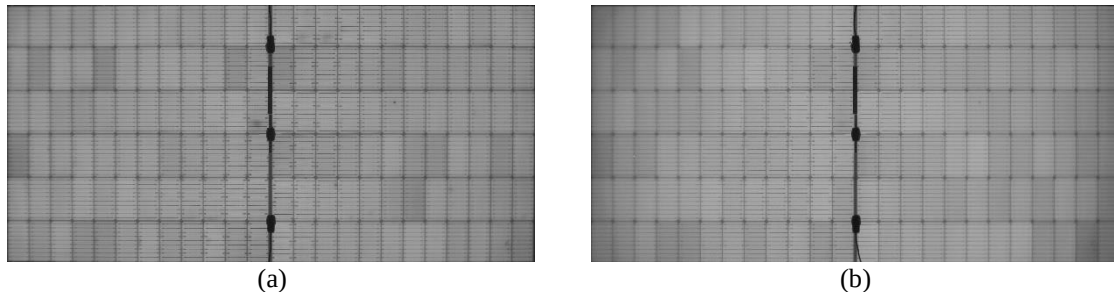
Fig. 7 presents the results of the electroluminescence (EL) tests conducted before and after the appearance of cracks. The images show that, despite the visible cracks in the glass, no damage or microcracks were detected

in the solar cells, indicating that the electrical integrity of the module remained intact. These findings are consistent with the maximum power test results, which showed no performance degradation at this initial stage. This suggests that the degradation process occurs gradually, with potential impacts on power output and efficiency becoming evident only over time. Moreover, this phenomenon has been increasingly reported in large-scale photovoltaic power plants, where spontaneous glass cracks do not immediately affect electrical performance and are therefore undetectable through remote monitoring systems, requiring detailed on-site visual inspections for identification.

Fig. 7: EL picture of the Module 3 (a) before and (b) after the cracks.
