# Early and Abrupt Degradation of CIGS Systems Deployed in Diverse Climatic Conditions

This work presents a mid-term performance analysis of four CIGS PV systems installed in distinct regions of Peru: the coastal desert of Lima, the tropical rainforest of Chachapoyas, the semi-arid highlands of Tacna, and the extreme high-altitude conditions of Juliaca. Significant PR losses were identified in Lima and Juliaca, with values dropping from about 0.85 to 0.69 and 0.65, respectively, after one year and just four months of operation. In Tacna, the CIGS system declined to 0.77 after 18 months and remained stable, while in Chachapoyas, the PR dropped to 0.68 after 3.5 years but recovered to 0.75 in the fourth year. Upon identifying these deviations from the expected PR, an in-depth characterization was carried out on the Lima system. I-V curves and electroluminescence (EL) were performed, allowing the identification of power loss linked to decreased FF in the STC-translated I-V curves and revealing deactivated regions. To enable quantitative EL, a tool was developed to identify areas actively contributing to power.

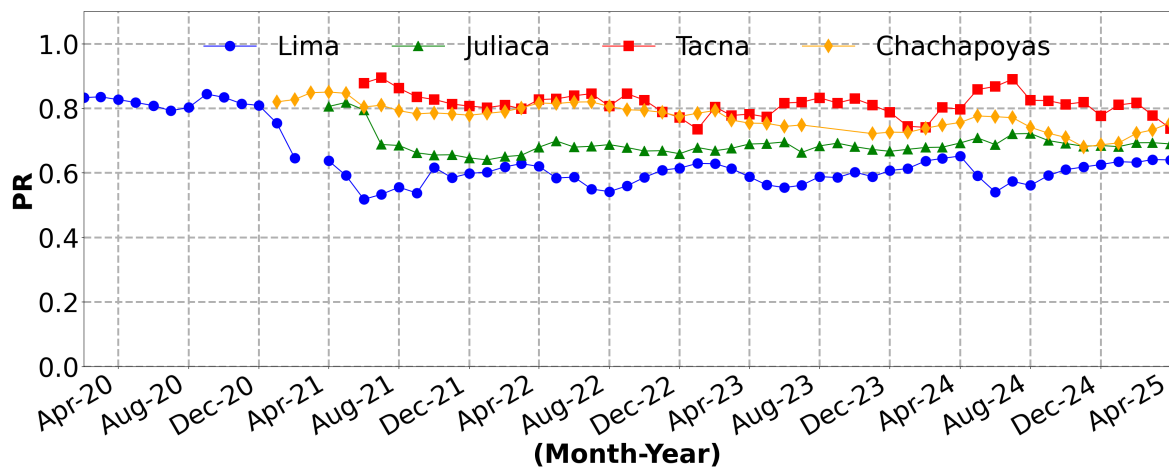
After one year of operation in Lima, the performance ratio PR experienced an abrupt drop from values from 0.85 to a low of around 0.55. Part of the fluctuations in Fig. 2 is attributable to seasonal module-temperature; the extended proceeding will therefore provide temperature-corrected PR values. In the following months, however, a gradual recovery was observed, with the PR rising again to approximately 0.65. In Juliaca, the PR loss occurred even earlier: just four months after commissioning, the PR fell to 0.68. Since then, the system has partially recovered and maintained a stable PR of around 0.70. By contrast, Tacna and Chachapoyas exhibited more moderate declines—to 0.77 and 0.68 respectively—followed by a partial recovery (in Chachapoyas the PR returned to 0.75).

Fig. 2: PR monthly estimation for all locations, abrupt drop occurs in Lima and Juliaca.

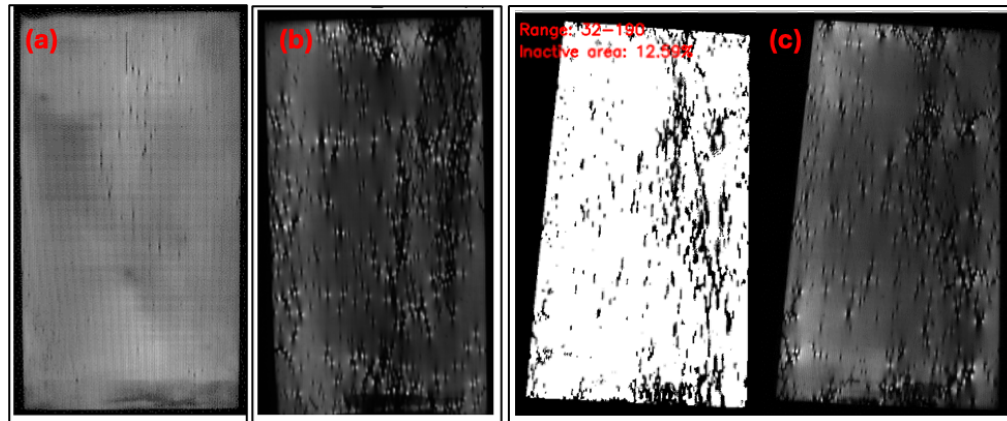
To investigate the abrupt losses observed in Lima, diagnostics were carried out using EL imaging and I-V curve tracing. In Fig. 3, panel (a) shows a control module that was never exposed to outdoor conditions, while panel (b) displays a module from the system depicted in Fig. 1. The EL image (b) highlights regions where the module emits little or no luminescence—these dark zones correspond to areas in which electron-hole pairs

recombine non-radiatively, often due to defects such as shunts. In those shunted regions, useful current flow is severely reduced or entirely absent, preventing luminescence and causing the appearance of “black” or attenuated sectors. Conversely, bright spots in an EL image typically mark locations of unusually high current concentration, often adjacent to shunt defects where carriers accumulate around the faulty region.

Fig. 3: (a) shows the EL image of a reference CIGS module, (b) displays the EL image of a degraded outdoor-exposed, and (c) presents the identified inactive areas, quantifying 12.59% of the module surface as non-contributing.

To quantify how much of the cell area remains active, a script, available in the Zenodo repository (10.5281/zenodo.15293266), was developed to identify and measure regions still contributing to power generation. For the example in panel (b), this analysis determined the inactive area to be 12.5 %. It should be noted that partially shaded cells can become reverse-biased in a series string, driving stress currents through these defective regions. Studies have shown that even brief shading events can induce irreversible damage in CIGS modules under reverse bias (Silverman et al., 2017). Fig. 4 presents the measured I-V curves alongside the losses relative to the manufacturer’s STC values in Table 1. Noticeable reductions in Fill Factor (FF) reveal an increase in shunt resistance, consistent with the EL observations. The corresponding power curves indicate average energy losses of 20 %. FF losses and  $I_{mppt}$  losses are the most significant contributors to the PR decline, and the variability between modules indicates that localized defects and heterogeneous degradation are key determinants of overall CIGS system performance. Further analysis will be presented in the proceeding.

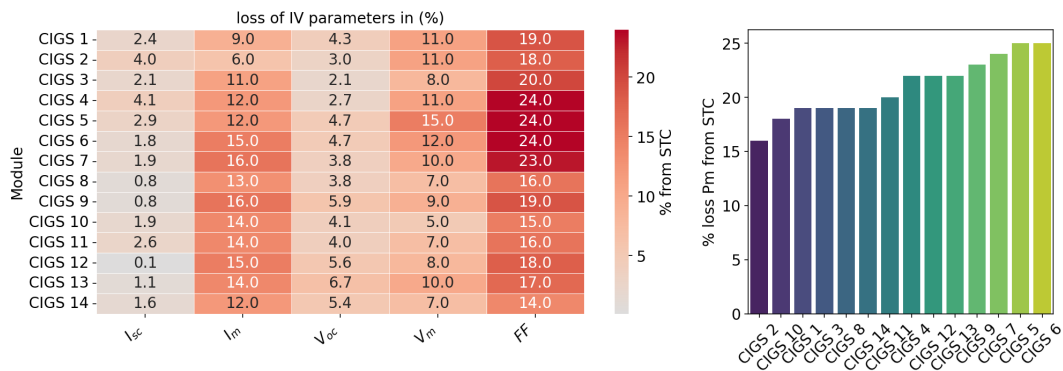
Fig. 4: Results of I-V curve translation to STC: the right panel shows percentage losses relative to the reference (Table 1), and the left panel shows STC power losses per module.
