FAULT ANALYSIS AND OPTIMISATION OF THE SOLAR THERMAL SYSTEM FOR DOMESTIC WATER AT THE UNIVERSITY OF APPLIED SCIENCES TRIER

Abstract

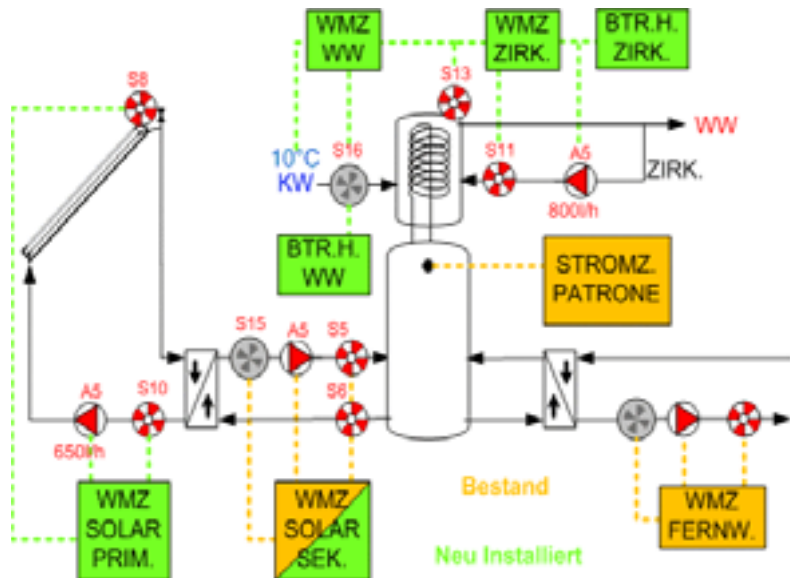
Fig. 1: Simple system scheme with counting devices

To make a statement about the system performance, the past records were consulted. Since 2006 the counters of the yellow measuring devices (see Fig.1) get read out once a week. The green counters were installed during this examination. To capture the losses of the circulation a flow rate was necessary, it was detected with an ultrasonic device.

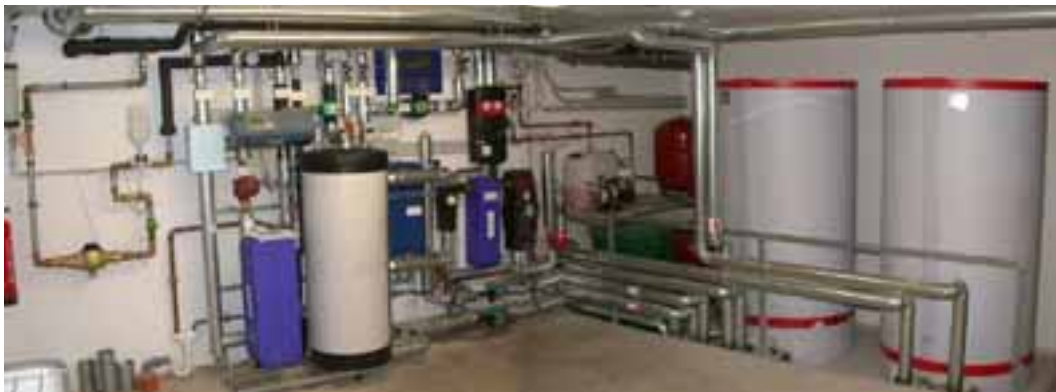
Fig.3: Technical room

To reduce the thermal losses (at the moment approximately 68%) the ventilation grille in the buffer room was closed. Further action is needed to insulate the central heating room, the largest losses occur in here. All pumps, heating lines and ball valves must be insulated, single glass windows should be replaced with double glazing.

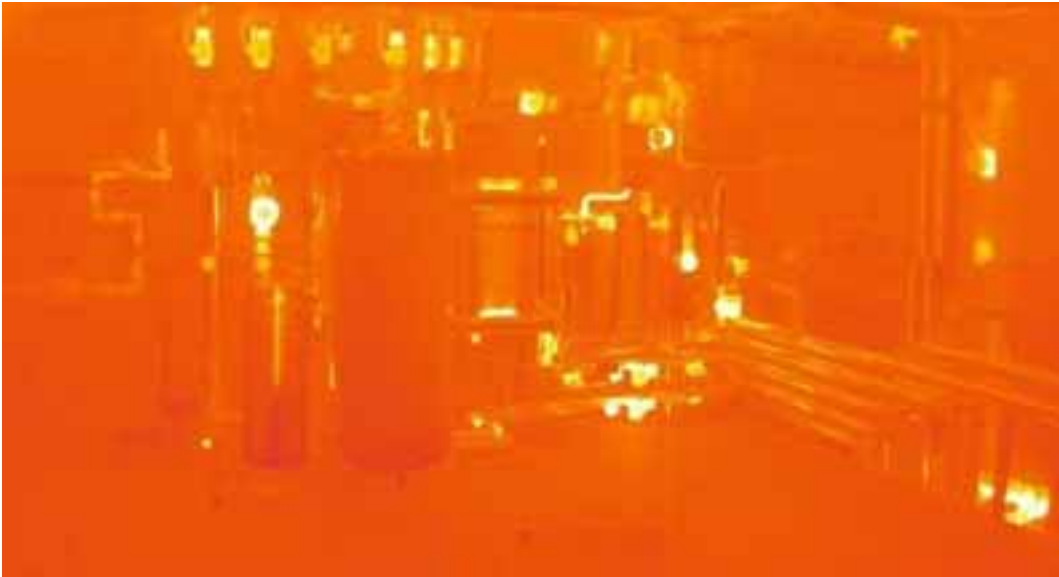
Fig.4: Thermographical recording of the technical room
