# COMPREHENSIVE EVALUATION AND MONITORING OF SOLAR THERMAL COMBISYSTEMS FOR DETACHED HOUSES

**Johann Breidler\* and Alexander Thür**

AEE INTEC, Department of Solar Thermal Components and Systems, Feldgasse 19, A-8200 Gleisdorf,

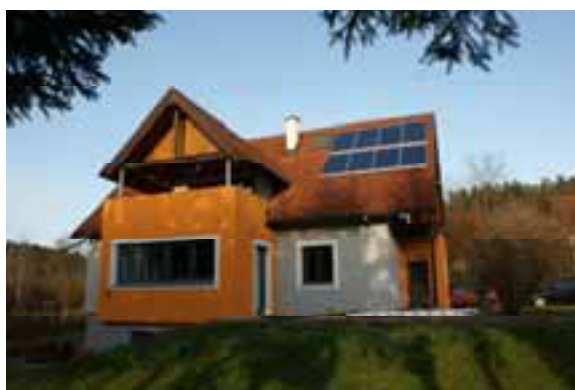
In Fig. 2 an example of an one family house in Austria is shown with integrated flat plate collectors in the roof how it is typically installed in Austria. Fig. 3 gives an overview on the typical sizes of the collector areas versus space heating area of the 70 one family houses which were evaluated within the entire CombiSol project.

Fig 2. Example of a detached house in Austria with 16 m<sup>2</sup> collector area

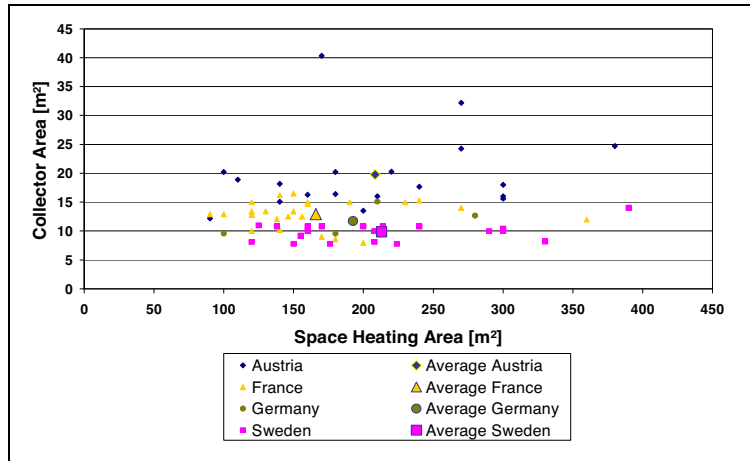
In Fig. 3 the distribution of the evaluated plants in the four participating countries is shown. The French, the German and the Swedish plants have a collector area in a range between 8 and 17 m<sup>2</sup>,

especially the Austrian plants have a range of collector area between 12 and 40 m<sup>2</sup>. The range of space heating area starts at 90 m<sup>2</sup> and ends at 390 m<sup>2</sup>.

Fig. 3. Collector area versus space heating area of the evaluated solar thermal combisystems

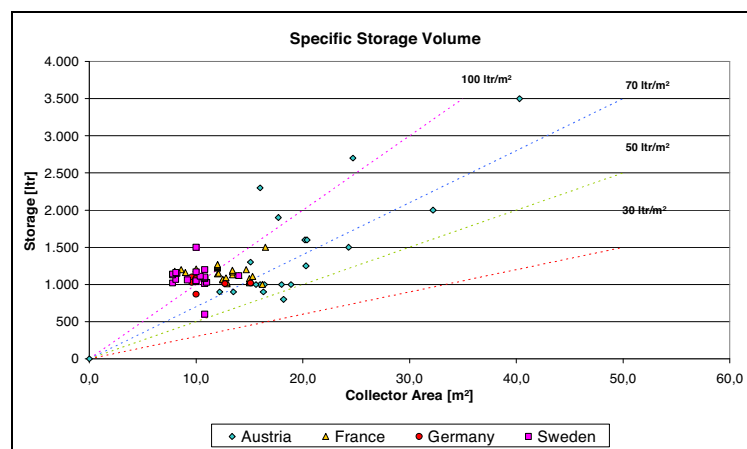
In Austria, 20 plants were inspected. In Fig. 4 the main dimensions of the solar thermal combisystems in the four participating countries are shown. The dimensions of the Austrian plants are between 12 and 40 m<sup>2</sup> collector area and between 800 and 3000 litres heat storage volume. During the inspection the specifically developed evaluation form had to be completed. The collected data allow the systems to be described in sufficient detail. Ten of the 20 evaluated combisystems have been equipped with measuring systems that record the measured data during a whole year, ending on December 31st, 2010. This was carried out by installing a heat meter in all hydraulic circuits, measuring the electricity consumption and oil and/or natural gas consumption of the entire heating system, as well as installing a pyranometer in collector plane.

Fig. 4. Heat storage volume versus gross collector area of the 70 evaluated plants

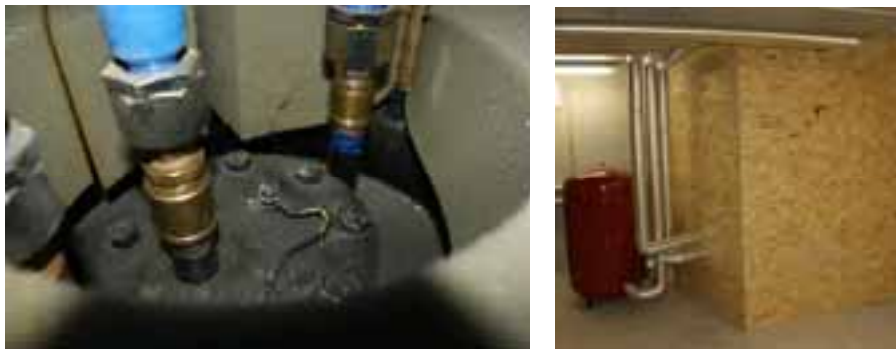
- Not or bad insulated areas and pipe connections in the hot part of the tank (Fig. 5 and Fig. 6)
- Not or bad insulated connections between two heat storage tanks
- No thermosiphon traps installed
- Generally bad workmanship of the heat store insulation
- Vertical gap between the hard foam shells
- Air gap between the insulation and the tank

Fig. 5. Very poor heat storage insulation at the top of a tank (left), good alternative of heat storage insulation, on site build box filled with cellulose insulation material (right)

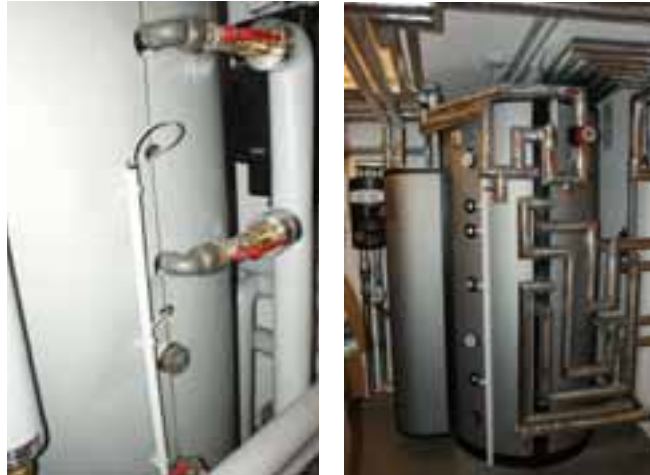
Fig. 6. Heat storage tank connections are not insulated (left), storage tank with exemplary good thermosiphon heat trap installation of the pipe connection (right)

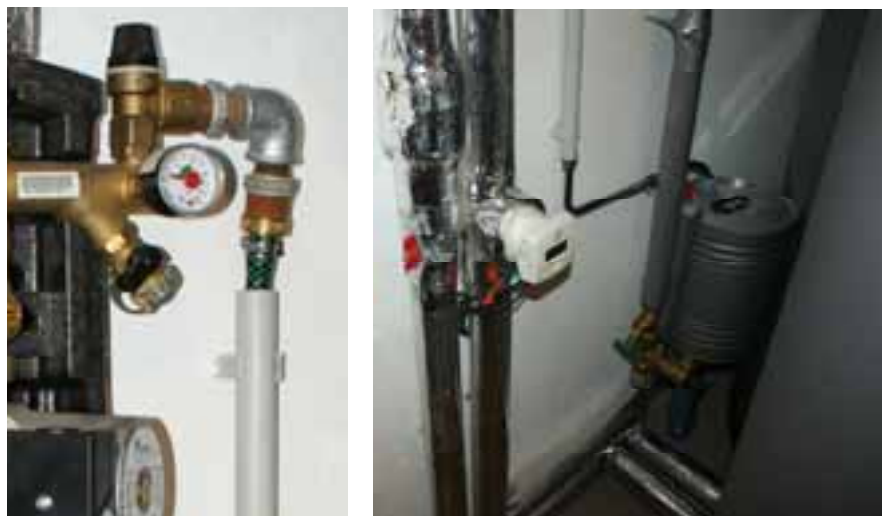
- Isolation valve between pressure relief valve or expansion vessel and hydraulic circuit which easily can be closed by anybody (e.g. children)
- Drain pipe and/or collection vessel not available
- Dimension of collection vessel too small
- Material of drain pipe and/or collection vessel was not temperature resistant ( $\gg 100^{\circ}\text{C}$ !)

Fig. 8. Drain pipe not temperature resistant (left), temperature resistant collection vessel, made of metal (right)

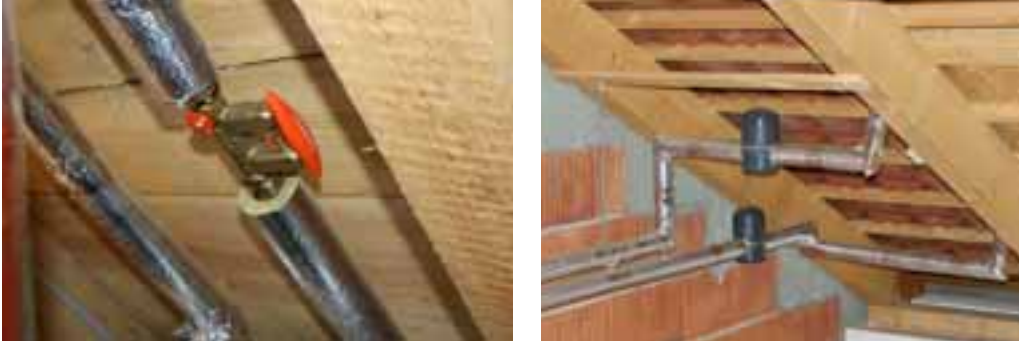
For components in close proximity to the collector in the case of stagnation temperatures up to  $200^{\circ}\text{C}$  (superheated steam) may occur. For components which are more distant from the collector, temperatures up to  $160^{\circ}\text{C}$  (saturated steam) must be expected. Consequently, when selecting components that are installed near the collector it is necessary to pay attention to their temperature resistance. In this category following mistakes were found:

- Automatic deaeration valves close to the collector (which allows steam to exhaust)
- Not temperature resistant flow regulation valves within high temperature critical parts of the collector loop

Fig. 9. Not temperature resistant flow regulation valve within high temperature critical parts of the collector loop (left), correct manual deaeration valves within high quality insulation (right)

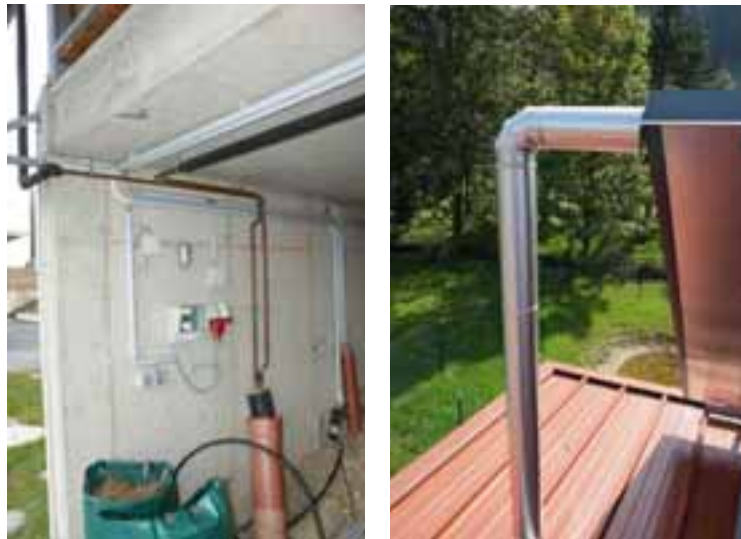
- Fittings are not insulated
- Bad workmanship of the pipe insulation respectively the pipes are only partly insulated
- The pipes in the whole heating system are not insulated
- No protection of the external insulation against UV-rays and animal bites
- Wrong dimension of the insulation (gap between pipe and insulation)
- Not temperature or water resistant insulation material in the solar circuit

Fig. 10. External pipes insulated only partly (left), correct protection against UV-rays and animal bites (right)
