## ISES SWC2015

### Evaluation of the Impact of Stagnation Temperatures in Different Prototypes of Low Concentration PVT Solar Panels

#### Abstract

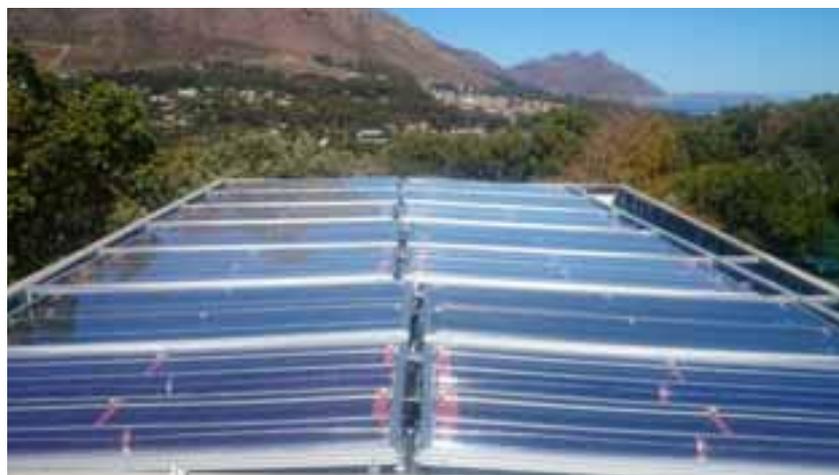
Fig. 3 -Test installation at latitude 30°

Eight C-PVT collectors and six concentrating thermal (T) collectors were installed in a warm country as show in figure 3. The eight C-PVT collectors were connected to eight micro-inverters. Four thermal loops were connected to a central tank. Three loops contained two PVT and two T while one loop had only two PVT collectors.

The water outlet was not connected in the first day which was a very sunny and warm summer day. This implies that the collector has reached stagnation temperature which is around 175 °C.

One hour after installation, the combined output of the eight PVT was measured and found to be only 1200 W (el) instead of the expected 1920W (el). It should also be noted that the eight PVT collectors may also have been exposed to sunlight without cooling, prior to the installation. In the morning of the following day, the electrical production of the installation was again measured and it had been greatly reduced to only 200W.
