## SOLAR THERMAL COLLECTOR'S DEGRADATION – INFLUENCE OF CORROSIVITY INSIDE AND OUTSIDE THE COLLECTORS

M.J. Carvalho<sup>1</sup>, S. Páscoa<sup>1</sup>, N. Mexa<sup>1</sup>, R. Gonçalves<sup>1</sup>, J. Correia<sup>1</sup>, A. Gano<sup>1</sup>, T. Diamantino<sup>1</sup>

<sup>1</sup> LNEG - Laboratório Nacional de Energia e Geologia I.P., Lisboa (Portugal)

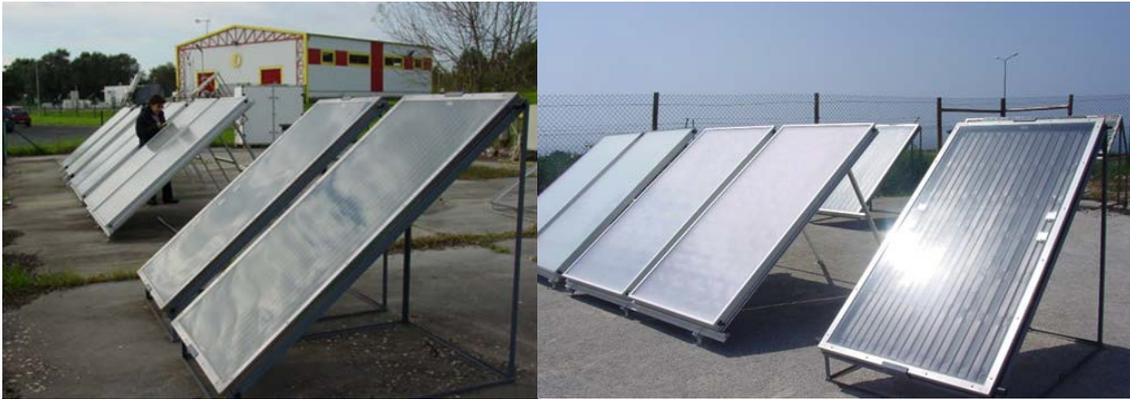
Fig. 1: Installation of collectors in OET sites - Urban (left); Maritime/Industrial (right)

For each collector model, two samples were exposed in each OET sites (see Figure 1). Thermal performance was measured before exposure for each collector model. For three of the models, zinc standard specimens were installed inside one of the collector samples. After two years exposure, thermal performance was measured. Preliminary results for one of the OET sites were presented in (Carvalho et al., 2016). Summary of all thermal performance results are presented in this work, in section 3.2.

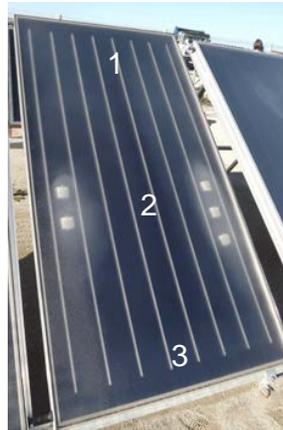
**Fig. 2: STC with zinc reference materials and the indication where environmental contaminants were collected after dismantling of collectors**

In each of the collectors referenced in Table 1 with \*, five (5) replicates of zinc metal samples were put in the air gap between absorber and glazing (Carvalho, et al, 2016), to evaluate the corrosivity of the microclimate after approximately two years exposure. Zinc samples inside the collectors are equal to the zinc samples placed outdoors to comparatively evaluate the atmospheric corrosivity. The corrosion categories of outdoor exposure test sites were obtained by determination of the corrosivity based on corrosion rate measurement of standard specimens (carbon steel, zinc, copper and aluminum) according to ISO 9223: 2012 and ISO 9226:2012 during

The atmospheric contaminants present in the solar absorber surfaces, inside the collectors, were also collected by Bresle method (ISO 8502-6, 2006) and analyzed by Ion chromatography. Atmospheric contaminants were analyzed in three different parts of the collectors (1, 2 and 3). In Figure 2 is possible to see the zinc reference materials (5 samples) and where environmental contaminants were collected (1, 2 and 3),

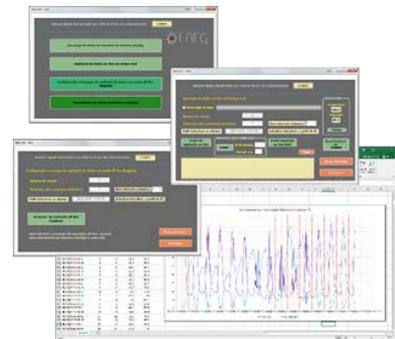
**Fig 4.** System's user interface for configuration and data gathering

A custom user interface software (see Figure 4) was also developed for system's configuration and logged data gathering. The software application runs under Windows environment, allowing an easy system's operation. The logged data can directly be imported into Excel datasheets using a standard text file with CSV format, being each recorded sample stamped with Date/Time information from the system's internal real-time clock, synchronized with the computer's clock when the system is initially configured to start acquisition.
