Low cost electroluminescence lab implementation

Abstract

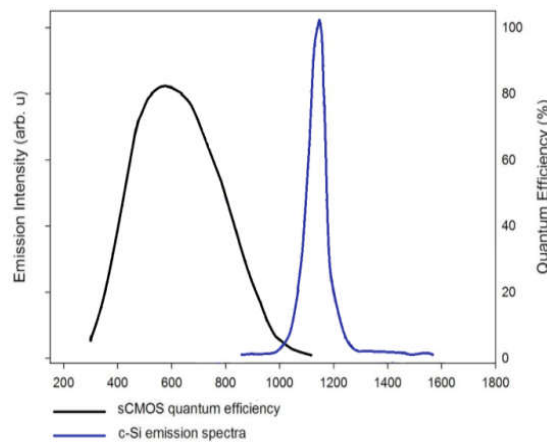
Fig. 2: Emission spectral from a range of crystalline silicon solar cell and the quantum. Adapted from Jahn *et al.* (2018).

The emission peak occurs with a wavelength distinct of visible light (400 – 700 nm). Special cameras are used with detectors that cover the spectral range (900 – 1300 nm) (electromagnetic spectra infrared range) indicated in figure 2 (Frazão, 2016). An example is the Canon EOS M3 - PV vision EL that has a spectral range around 1100 nm. Photos like the one shown in figure 1b are taken with this kind of equipment, but they're expensive; close to US\$ 6,100 (Bedin *et al.*, 2018).

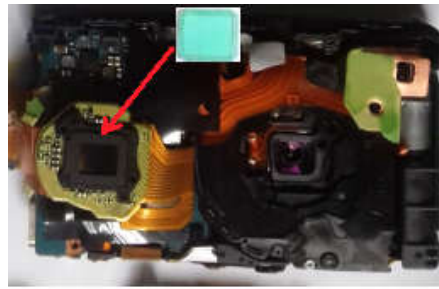
Fig. 5: Optical globe dosked with the filter removed (blue part).

The figure 5 presents the optical filter (in blue) and the sensor without it (red arrow). After ending the procedure described, all parts of DSC-WX9 must be assembled; after that, the camera will be able to take EL photos of PV modules.

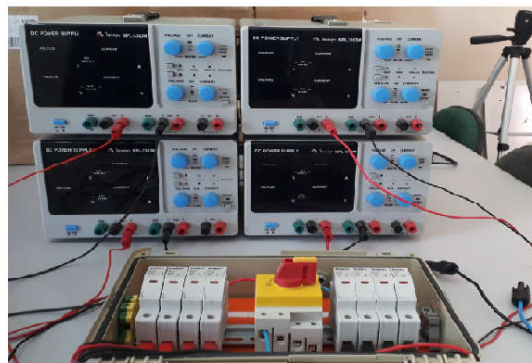
Fig. 6: a) Four power sources configured in serial mode and connected in parallel, b) Electrical circuit relative to this configuration, c) Electrical circuit with one power source configured in independent mode.

According to Petraglia and Nardone (2011), the EL test must be done injecting electrical current in the PV module positive terminal. It was used the voltage sources Minipa model MPL-3303M (two independent sources of 32 V and 3 A) (figure 6a); this equipment could be configured in maximum as one source of 64 V and 3 A. The PV modules tested were a 50 Wp ($I_{sc} = 3.04$ A and $V_{oc} = 21.56$ V) and a 255 Wp ($I_{sc} = 9.01$ A and $V_{oc} = 37.7$ V). Four voltage sources were connected to supply suitable values of voltage and current. For instance, the test of 50 Wp module used only one source (figure 6c) and for the 255 Wp test, four power sources were connected in parallel (figure 6b).
