# Mitigating thermal derating in photovoltaic inverters: insights from a real grid-connected system

Beatriz Almeida Rodrigues e Silva Melo<sup>1</sup>, Tiago Alves Fernandes<sup>1</sup>, Elielza Moura de Souza Barbosa<sup>2</sup>, Fabrício Bradaschia<sup>1</sup>, Rinaldo Oliveira de Melo<sup>2</sup>

<sup>1</sup> Universidade Federal de Pernambuco/Departamento de Engenharia Elétrica, Recife (Brazil)

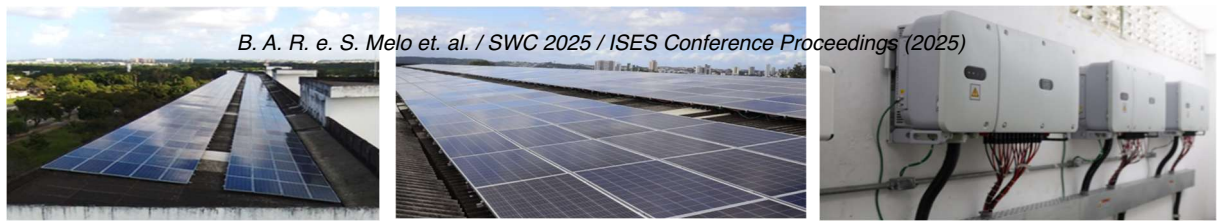
**Figure 1: General view of the photovoltaic array composed of 792 p-Si modules (345 Wp each), illustrating partial cloud shading and the group of three 60 kW inverters (Silva et al., 2024).**

The methodology adopted in this study was structured into four main phases: collection of operational data, comparative analysis of energy generation, thermal assessment of the inverters, and performance simulations. Initially, real operational data were collected from the Grid-Connected Photovoltaic System (GCPS) installed at the Center for Technology and Geosciences (CTG) of the Federal University of Pernambuco (UFPE). The system consists of 792 polycrystalline silicon (p-Si) photovoltaic modules, each rated at 345 Wp, resulting in a total installed DC capacity of 273.24 kWp. The array is connected to three 60 kW string inverters, yielding a combined nominal AC power of 180 kW. The PV modules are mounted with a 10° tilt angle facing north, corresponding to the optimal inclination for local latitude and an azimuth of -84.3°.

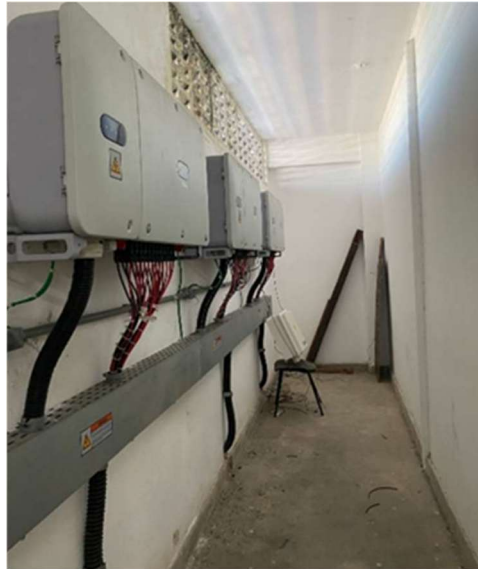
The inverters were mounted on a west-facing wall exposed to direct solar radiation during the afternoon and located in a confined room with limited air circulation. These conditions are unfavorable for natural convection and explain the sustained high internal temperatures observed. According to manufacturer guidelines, inverters should be installed in well-ventilated environments and protected from direct sunlight — conditions not fully met in the CTG/UFPE system.

**Figure 3: Inverter's installation site in the CTG/UFPE system (Silva et al., 2024).**

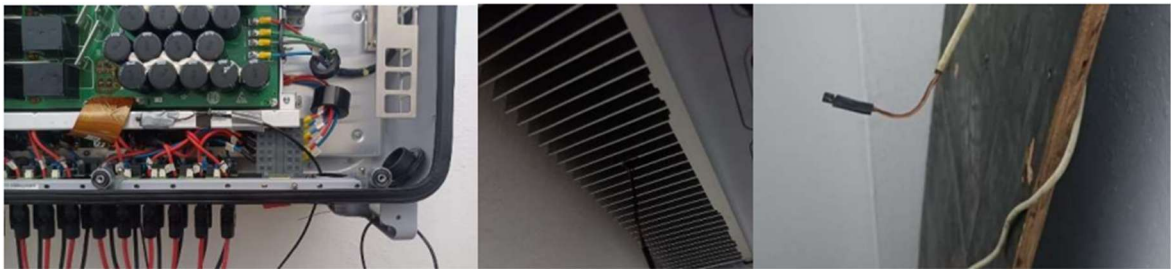
As discussed in Lima et al. (2023), is important to analyze the influence of the inverter's operating temperatures on its performance. Therefore, to more effectively monitor the temperature variations, five additional LM-35 sensors were positioned: two on inverter 1, two on inverter 2 and one to measure the room's ambient temperature, Figure 4. Furthermore, a fan was aimed at the inverter 1 to force ventilation and observe if a decrease in operating temperature occurred. The fan was installed using an EKAZA smart plug, which allowed its operation to be controlled via a simple mobile application as shown in Figure 5. It is important to note that the fan was positioned to respect the equipment's natural convection flow, as shown in Figure 6.

**Figure 4: New sensors installation (Silva et al., 2024).**

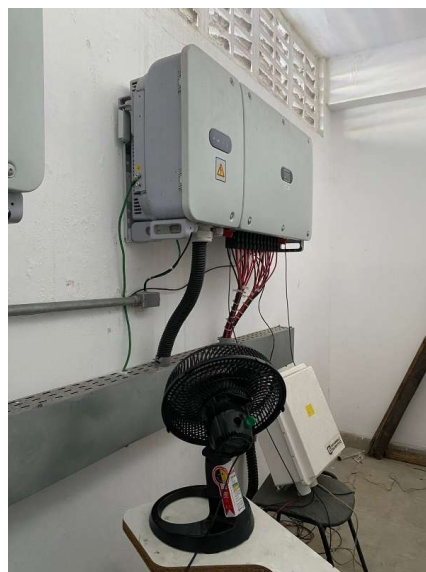
**Figure 5: Fan positioning.**
