Failure rate determination and Failure Mode, Effect and Criticality Analysis (FMECA) based on historical data for photovoltaic plants

Sara Gallardo-Saavedra^{1,2}, Javier Pérez-Moreno², Luis Hernández-Callejo¹ and Óscar Duque-Pérez³

Abstract

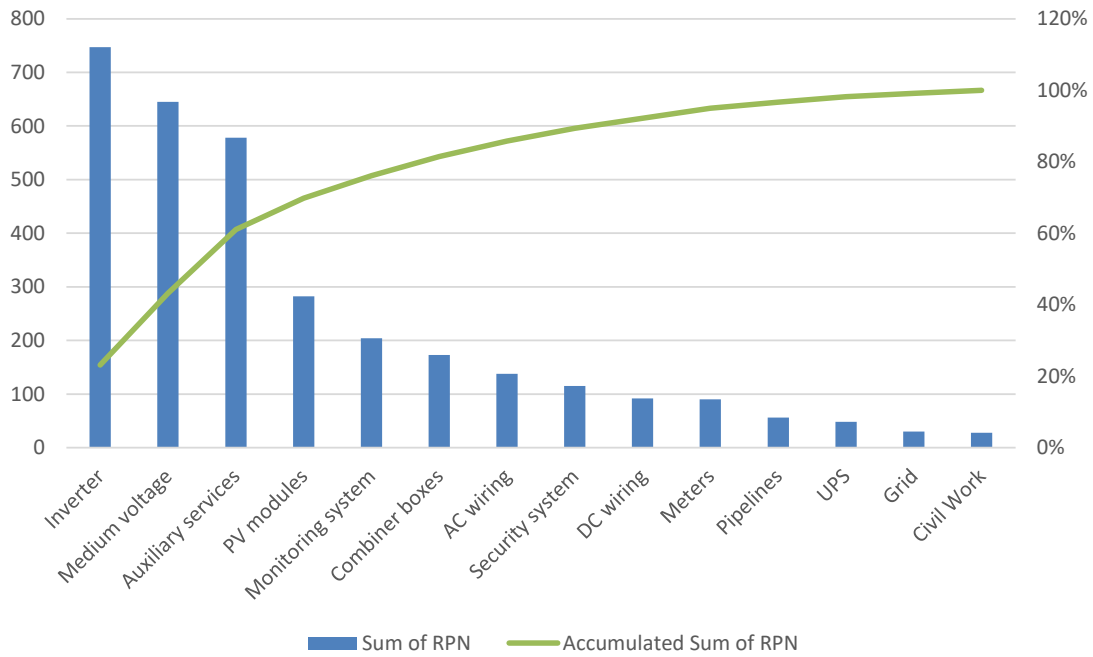
Fig. 1: Sum of RPN per group - FULL O&M

It can be seen that the inverter presents the higher RPN sum for the identified failure modes, followed by the medium voltage and the auxiliary services. Due to the fact that not all the groups present the same number of failure modes identified, it is necessary to know the average RPN in each of the groups. This analysis can be seen in Fig. 2. It can be seen that in this case, the groups that present a higher RPN in average are the medium voltage and the inverters, followed by AC wiring, combiner boxes, pipelines and PV modules.
