# ANALYSIS OF FAILURE AND DEGRADATION MODES OF SMALL-SCALE PHOTOVOLTAIC POWER PLANTS IN RURAL COMMUNITIES OF THE ATACAMA DESERT

## Abstract

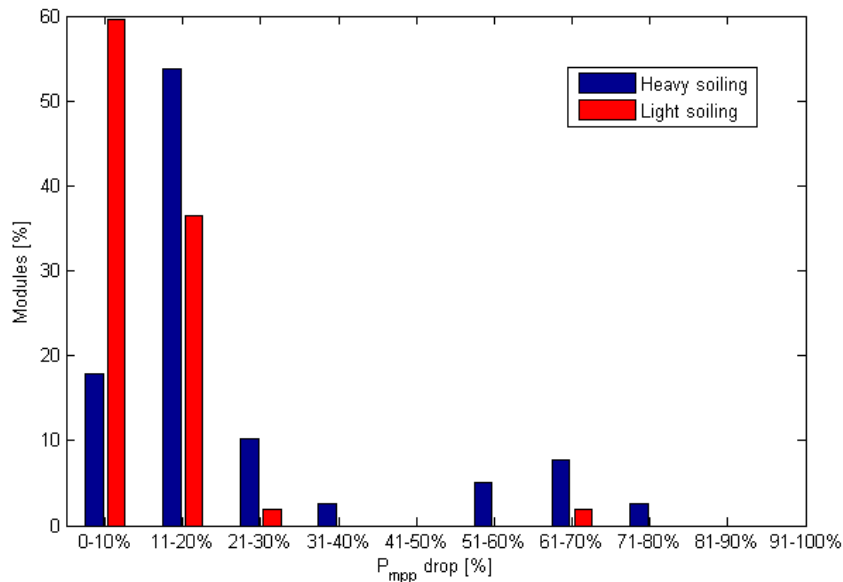
Fig. 2: Effects of degrees of soiling (light or heavy) on the maximum power point.

Moreover, depending on the distribution of soiling layers, additional thermal stress can be induced. From lightly soiled modules, it was found that 85% of them show  $I_{sc}$  reduction of less than 10% from the nominal value, while all of them show a reduction less than 20% from the nominal value. On the other hand, 80% of heavily soiled modules show  $I_{sc}$  drops up to 20%. However, 15% show  $I_{sc}$  drops higher than 40% from nominal value. Regarding to  $V_{oc}$ , both lightly and heavily soiled modules show drops less than 10% from the nominal value (except in two cases, for which higher  $V_{oc}$  drops can be attributable to other causes). The effect of the reductions of  $I_{sc}$  and  $V_{oc}$  on  $P_{mpp}$  is graphically shown in Figure 2, where  $P_{mpp}$  drop trends are dominated by  $I_{sc}$  rather than  $V_{oc}$ . As it will be seen later, heavily soiled modules show more varied  $P_{mpp}$  drops given that severity of soiling layers is more varied for heavily soiled modules than for lightly soiled modules.

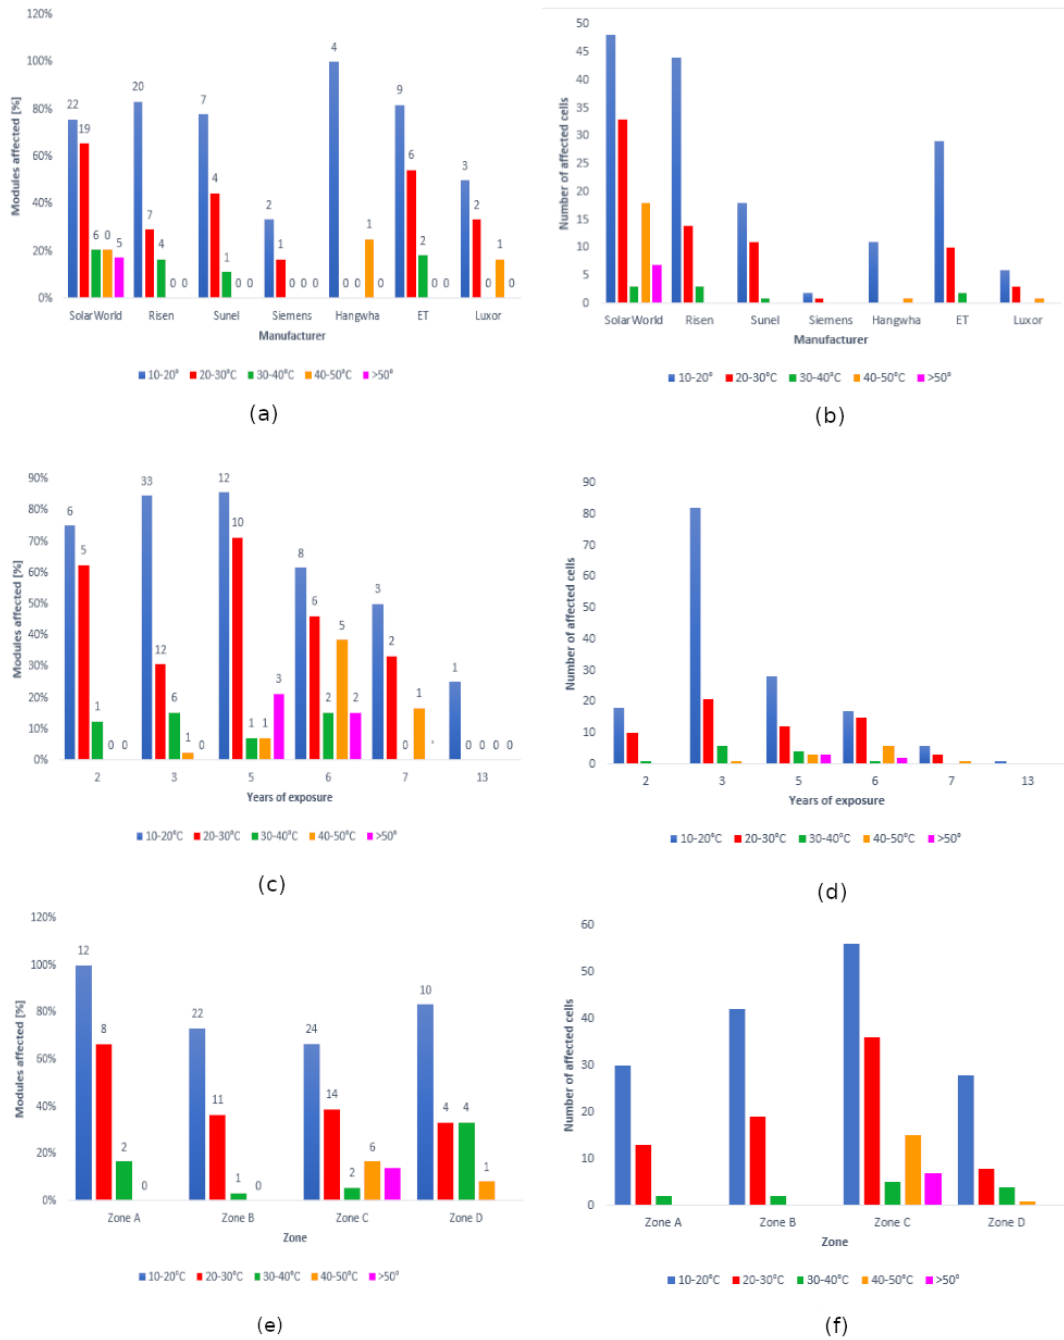
Figure 6: Hotspots occurrence divided in five temperature intervals, according to manufacturer, years of exposure and operating zone.

Hotspots were found to be a very common issue affecting the evaluated modules, with almost 80% of them showing thermal anomalies between 10-20 °C and 56% above 20 °C with respect to the average operating temperature of modules. Most modules show multiple hotspots, in some cases following known thermal patterns (short circuited module, potential induced degradation, etc.). However, other thermal anomalies show correspondence with visual defects such as milky discoloration of the front glass and the presence of drops or shading. Also, a pair of modules show thermal patterns attributable to cracks and defective soldering, but to ascertain this diagnosis a more detailed visual inspection (or the use of additional tools like microscope or electroluminescence imaging) is needed. From the total sample universe, more than 50% of modules were operating with light hotspots, while in zones A and C more than 50% of modules were operating with strong hotspots.

With a fast overview, it can be seen in a-b that only modules manufactured by SolarWorld show temperature differences above 50°C, with 17% of affected modules (5) and 7 affected cells. As shown in e-f, all these modules are in zone C, while the next higher temperature interval I<sub>4</sub> corresponds to modules of inner zones (coast and valley). Again, the higher number of hot cells correspond to those of zone C (SolarWorld), which indicates that the most severe heated cells are concentrated in a small number of modules, which also occur in zone B within the I<sub>2</sub> interval. The inverse situation occurs in zones A and D, where the total number of hot cells within the interval I<sub>1</sub> is distributed in (almost) all the modules of these zones. Within I<sub>3</sub>, again SolarWorld shows the highest number of affected modules followed by Risen, but with only a few number of affected cells. The less affected modules were Siemens, Hangwha and Luxor, both in number of modules (6, 5, 6 respectively) and severity (no higher than I<sub>3</sub>).
